Town of Aurora (Erie County)

Protecting and Restoring Water Resources Together

Importance of Headwaters Communities – TOWN OF AURORA

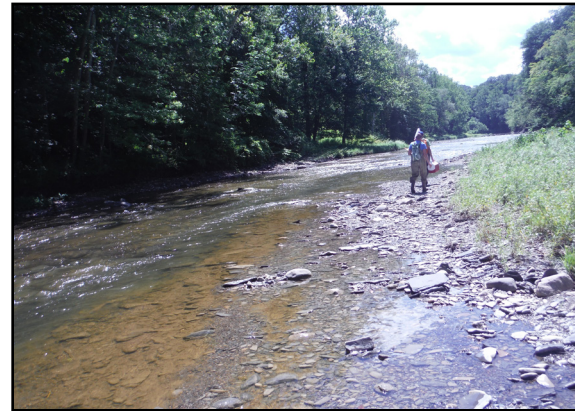
Waterkeeper performing stream assessments in Cazenovia Creek

- Waterkeeper visually assessed 10 miles of Cazenovia Creek in Aurora
- Multi-year water quality data set of Hunters Creek
- Elevated nutrient levels throughout Aurora observed through Waterkeeper sampling
- Bacterial data collected indicates elevated levels of *E.coli* in Cazenovia Creek West and East Branch

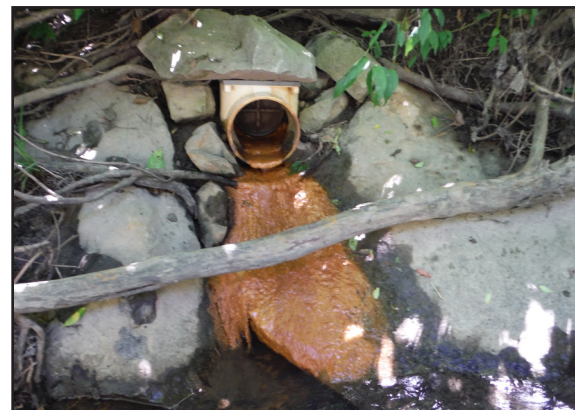
Excess nutrients can result in algal growth - East Branch Cazenovia Creek

Elevated phosphorus and nitrate levels are present throughout Cazenovia Creek (all branches) in Aurora. Through targeted education and best management practices, nutrient runoff from farms and residential lands will be reduced.

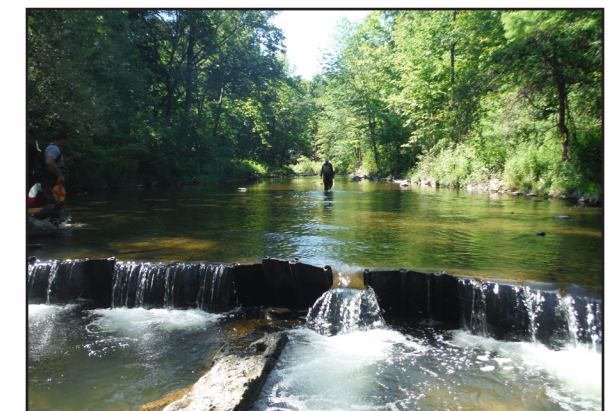
Example of a Fish Barrier Limiting Fish Passage - East Branch Cazenovia Creek

Improperly sized or placed culverts can impede the passage of fish and other wildlife through a stream. Culverts and other barriers can prevent these species from reaching food sources, spawning locations, or cold water habitats.

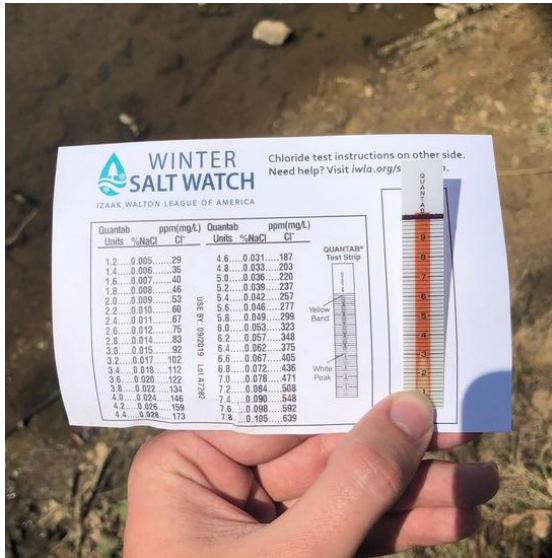
By conducting a simple (and quick) chloride test, Aurora can learn how road salt applied to 20A (Quaker Rd) and other roadways is impacting Cazenovia Creek and other streams.

Izaak Walton League of America (a National conservation organization) can provide FREE test kits that are very easy to use. Extra test strips can be purchased on Amazon.

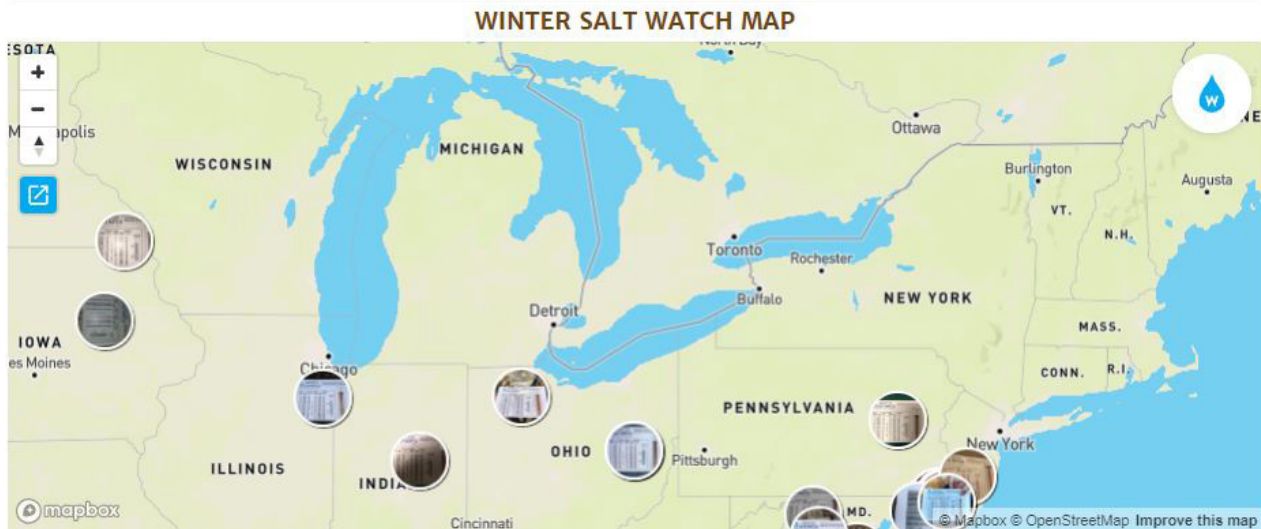
Using Water Reporter, the user records the location of excess road salt near a waterway. This Program is used throughout the Midwest and East Coast.

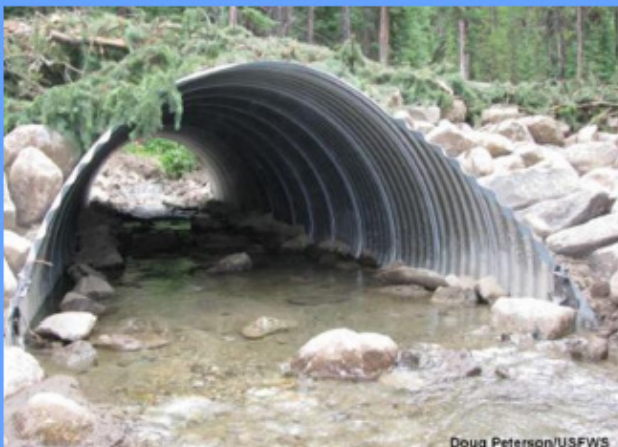
Embedded Open-Arch Culvert

- ◆ Natural substrate, large cobbles, and pools in the culvert provide habitat and places to rest
- ◆ Water velocity, slope, and depth match upstream and downstream conditions
- ◆ Safe passage for wildlife through the corridor

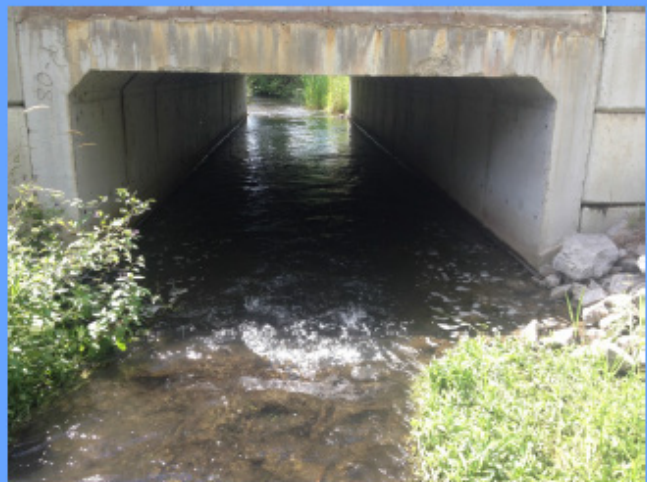
Box Culvert

- ◆ Capable of handling high flows during storm events and provides safe resting areas
- ◆ Maintains flow during dry conditions
- ◆ No physical obstructions to passage
